Bureau of Land – Field Operations Section

Evaluation Report

BOL ID:	1190400007	Region:	Collinsville
USEPA ID:	ILD096731468	County:	Madison
Site Name:	Mayco Mfg LLC (Formerly NL/Taracorp)	Phone:	618-451-4400
Address:	1200 16th St	Latitude:	38.69753
City/State/Zip:	Granite City, IL 62040	Longitude:	-90.15671

Evaluation Type	FSRS Oversight
Evaluation Date	11/10/2020
Inspector(s)	Miller, Tom
Person(s) Interviewed	Jeff Leed, Leed Environmental
Previous Inspection Date	5/7/2020

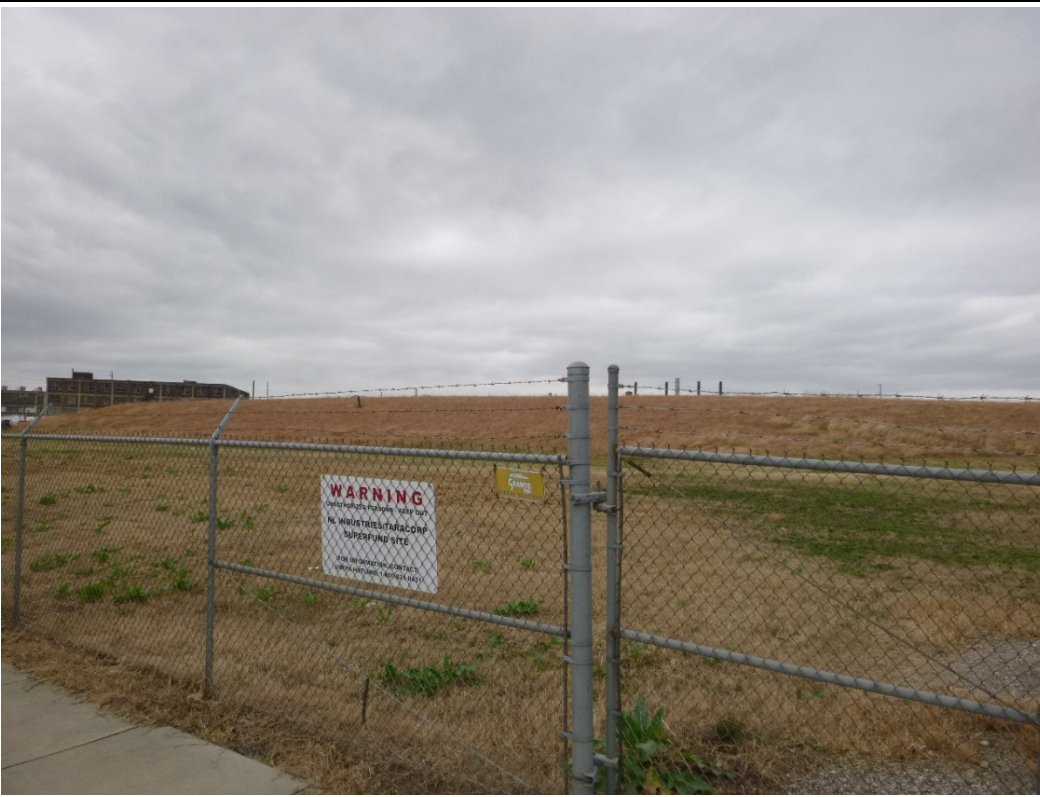
Photo ID: 1
Photo Date: 11/10/2020
Photo Time: 08:25
Direction: Southwest
Taken By: Tom Miller

Warning sign on entrance gate
to the NL/Taracorp battery
casing pile.

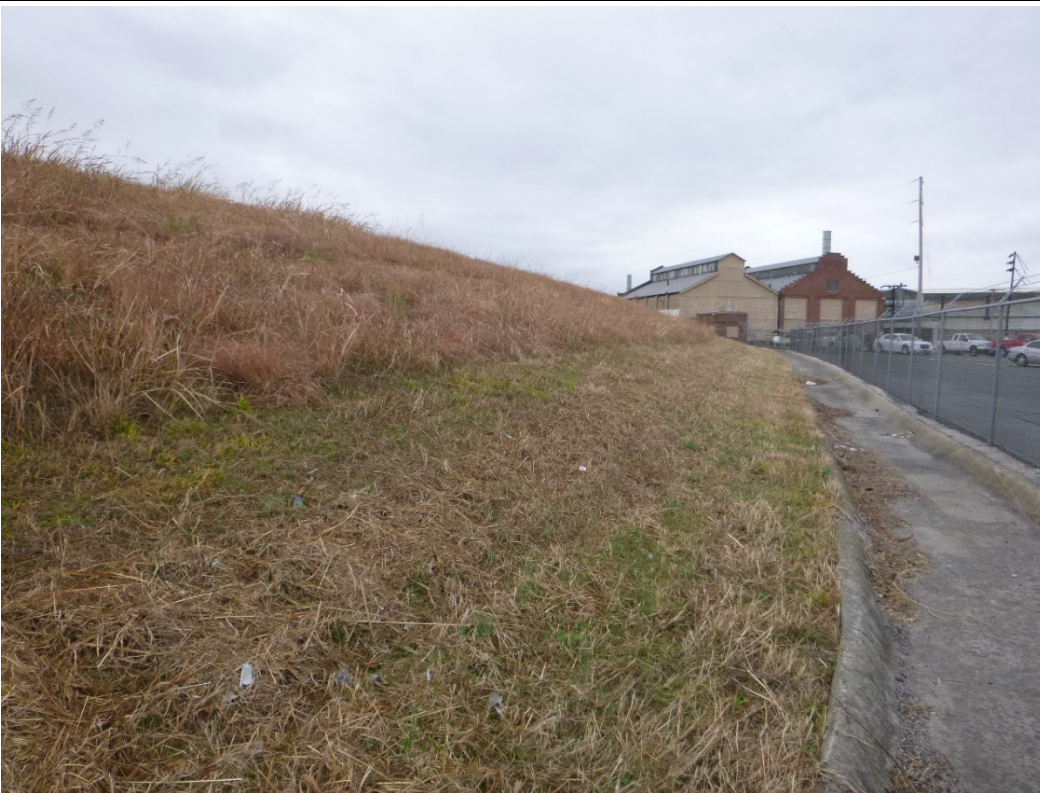
Photo ID: 2
Photo Date: 11/10/2020
Photo Time: 08:31
Direction: South
Taken By: Tom Miller

I met Jeff Leed at 0830 hours at the former NL/Taracorp site battery casing waste pile located at 1555 State Street in Granite City, Illinois. We started the annual site visit of the NL/Taracorp Superfund Project area by observing the area around the waste pile cap (See Figure 1 and Photos 1-3). The cap appeared to be in good shape. We observed an area in the southwest corner of the cap up against the fence where a pallet was leaning along the top. This pallet was moved off the fence by Mr. Leed and this writer.

West side of NL/Taracorp
battery casing pile.

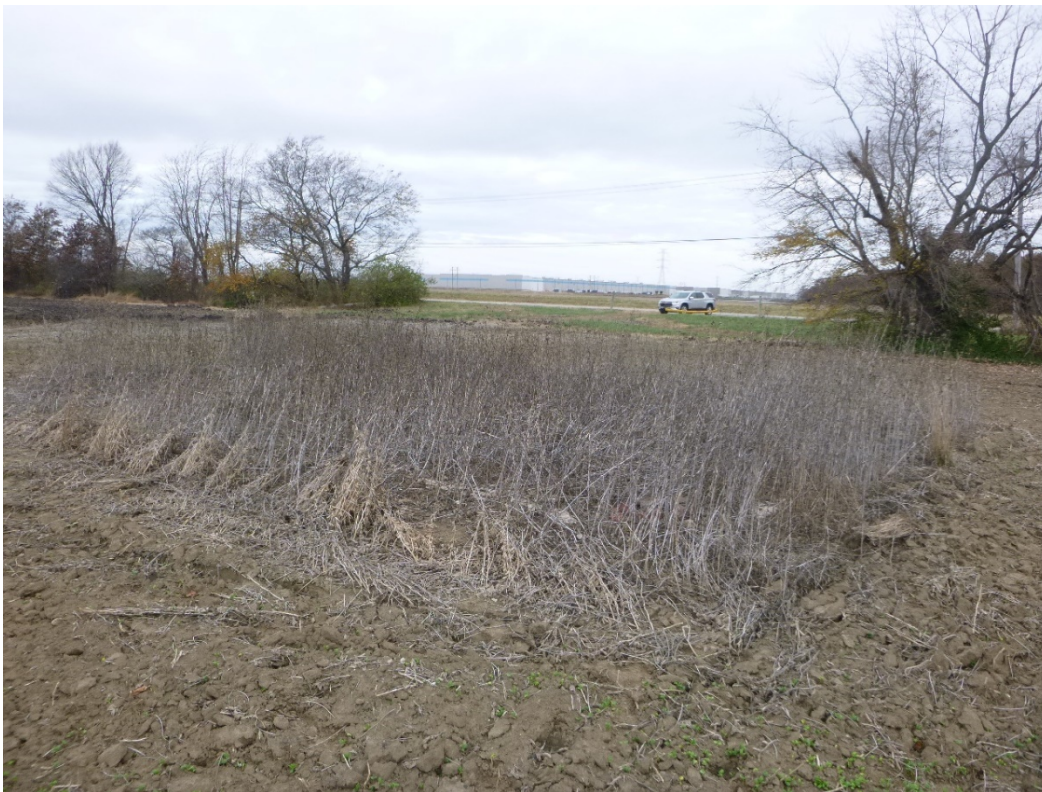
Photo ID: 4
Photo Date: 11/10/2020
Photo Time: 09:14
Direction: North/NW Indicated
Taken By: Tom Miller

Upon leaving the main NL/Taracorp Waste Pile Site, we visited the Sand Road Remote Fill Property (areas of former battery casing fill activities subject to previous cleanup activities performed by US EPA and their contractors). While on-site we observed the current conditions in and surrounding the former building foundation area located near the entrance to the property. I utilized a manual measuring wheel to determine the dimensions of the former foundation area. The measurements of this Area were taken within a rectangular area 29 feet by 38 feet. Battery chips were noted inside the foundation area and along the western boundary. (See Figure 2 and Photos 4-8).

Former home foundation area
on Sand Road Property.

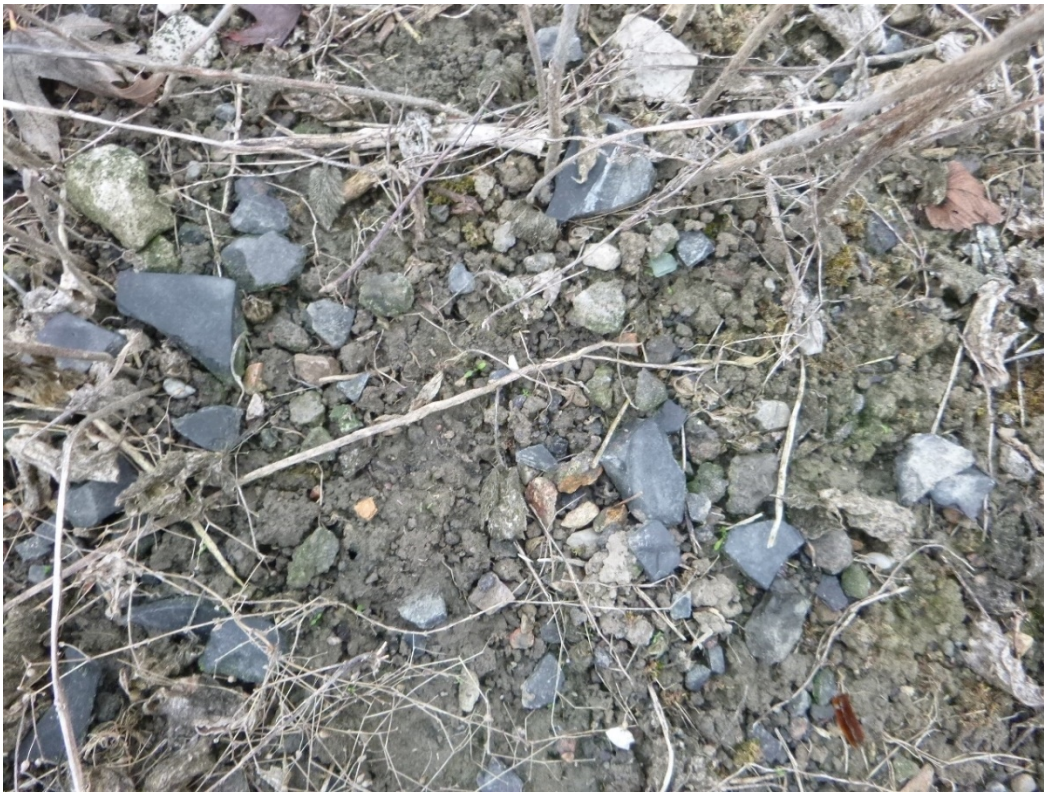
Photo ID: 5
Photo Date: 11/10/2020
Photo Time: 09:15
Direction: N/A
Taken By: Tom Miller

Battery chips observed within
former foundation area on
Sand Road Property.

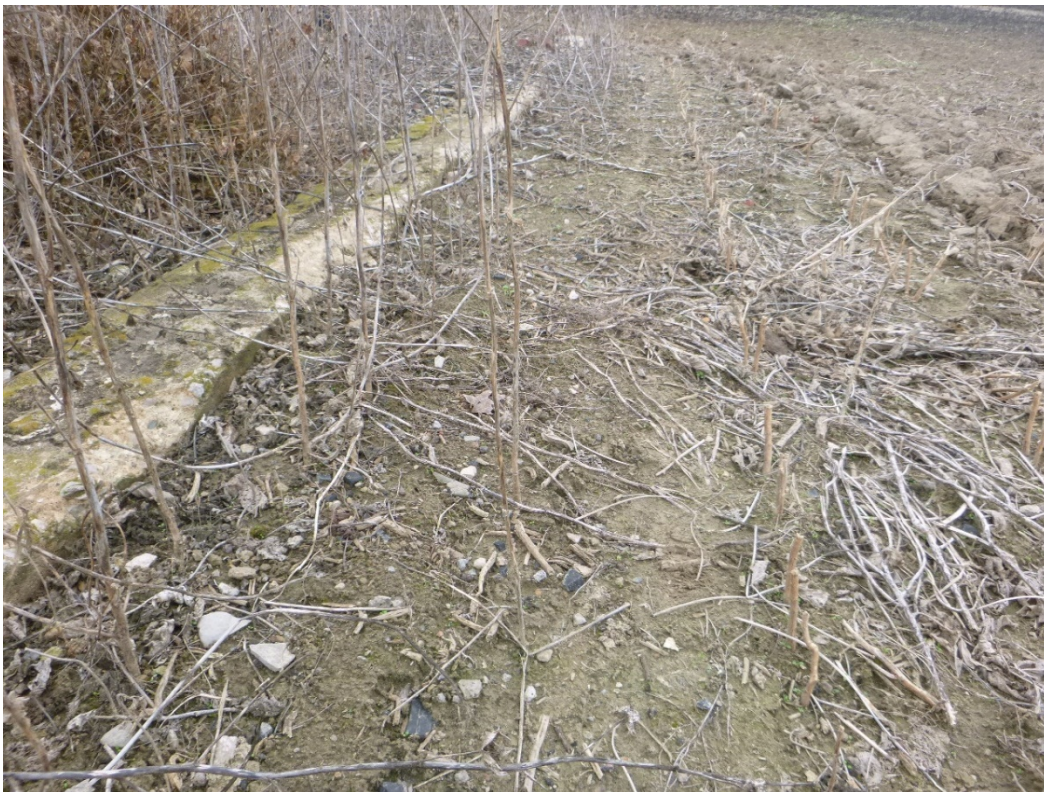
Photo ID: 6
Photo Date: 11/10/2020
Photo Time: 09:15
Direction: South
Taken By: Tom Miller

Western edge of former
foundation area on Sand Road
Property. Note scattered
battery chips.

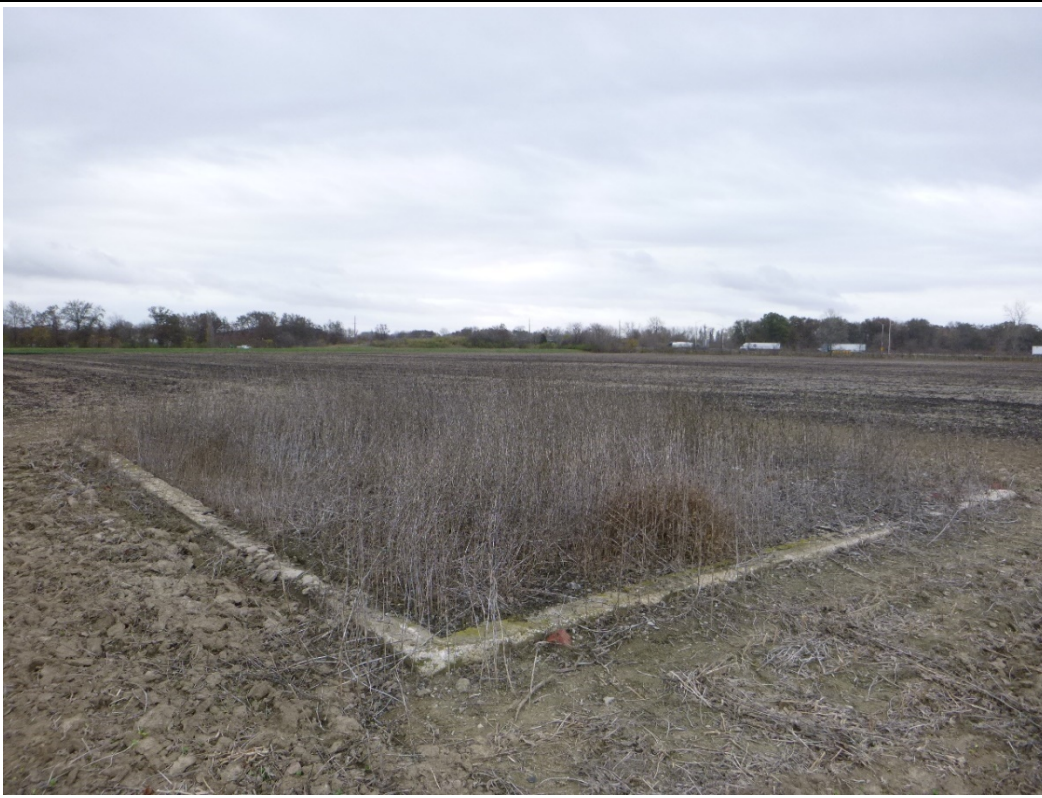
Photo ID: 7
Photo Date: 11/10/2020
Photo Time: 0920
Direction: Southeast
Taken By: Tom Miller

Northwest corner of former
foundation area on Sand Road
Property.

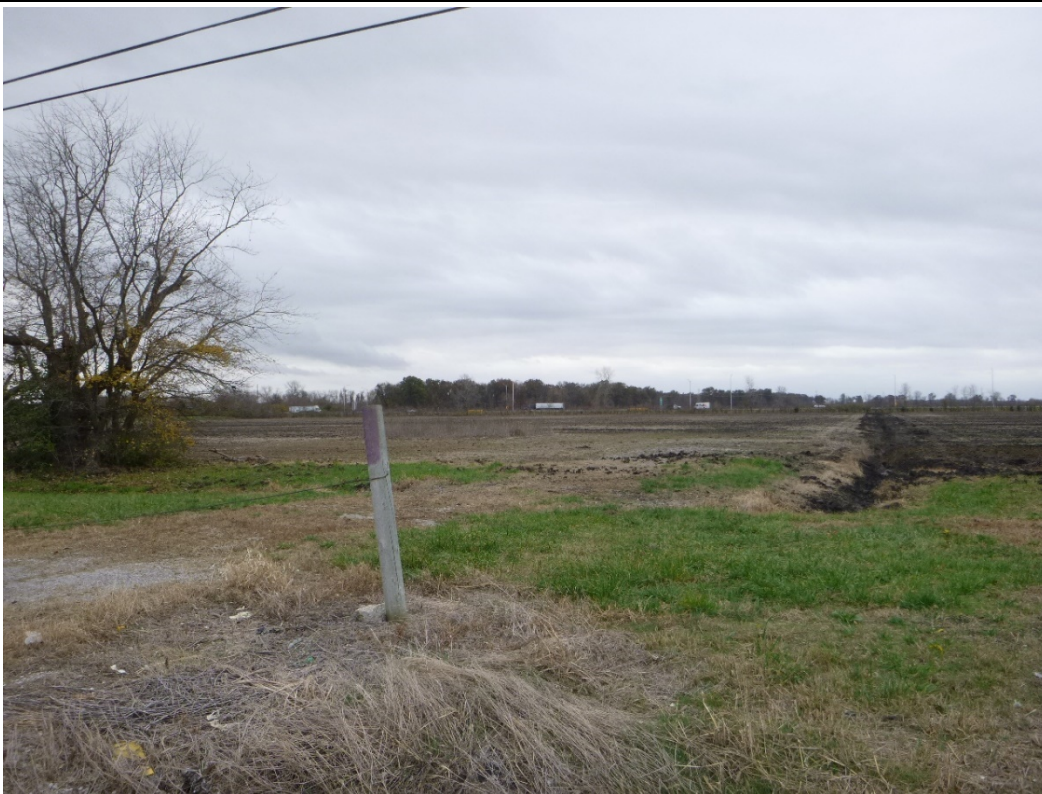
Photo ID: 8
Photo Date: 11/10/2020
Photo Time: 09:22
Direction: South/SE
Taken By: Tom Miller

Entrance road into Sand Road
Property.

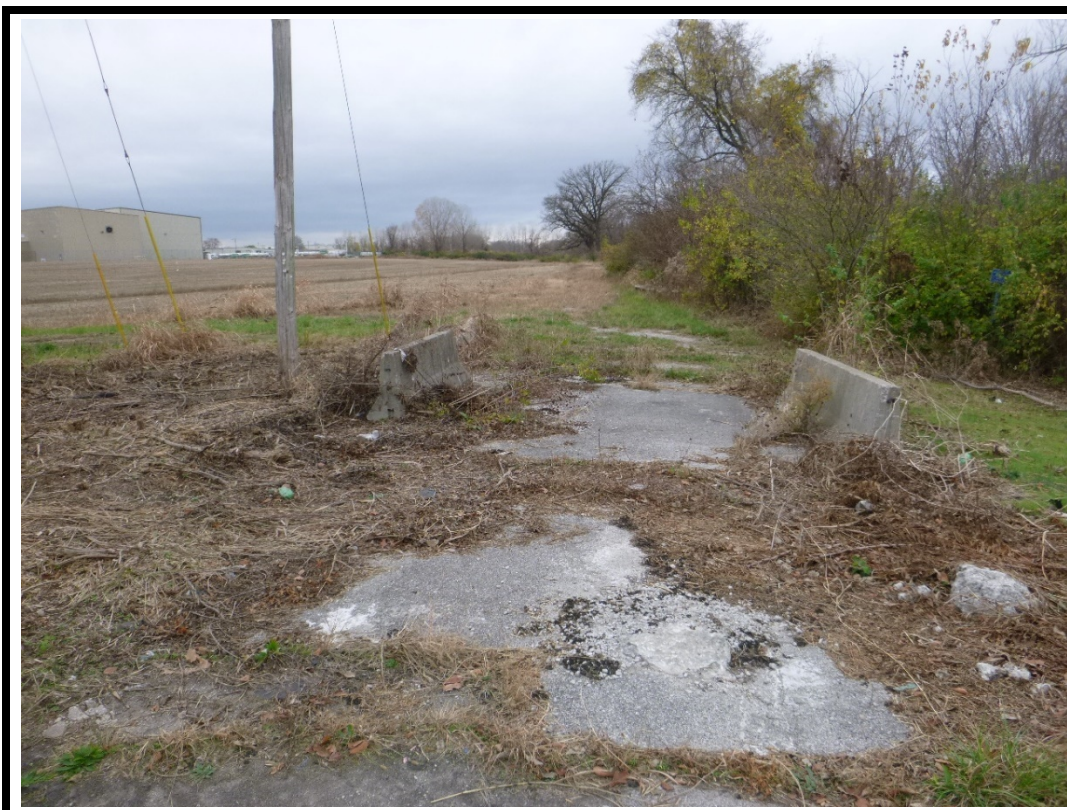
Photo ID: 9
Photo Date: 11/10/2020
Photo Time: 09:34
Direction: West
Taken By: Tom Miller

The next Remote Fill Property we observed was Schaeffer Road located on the West side of Illinois Route 3 in Granite City, Illinois. Upon entering the site, we walked along the elevated surface road that has agricultural fields to the south and wooded areas to the north. I utilized the measuring wheel to determine the distance to areas of previously observed battery chips. I measured from the concrete jersey walls located at the entrance into the site off of Route 3. Sparse scattered battery chips were located at the following locations: 862 feet from entrance, 893 feet from the entrance, 986 feet from the entrance and in an area surrounding a large diameter sanitary sewer manhole located approximately 1,028 feet from the site entrance (See Figure 3 and Photos 9-13). The area of scattered chips surrounding the sanitary sewer manhole area was measured at 50 feet by 25 feet.

Entrance road into Schaeffer
Road Property. Note concrete
jersey barriers. All site
measurements were taken
from the West side of these
barriers.

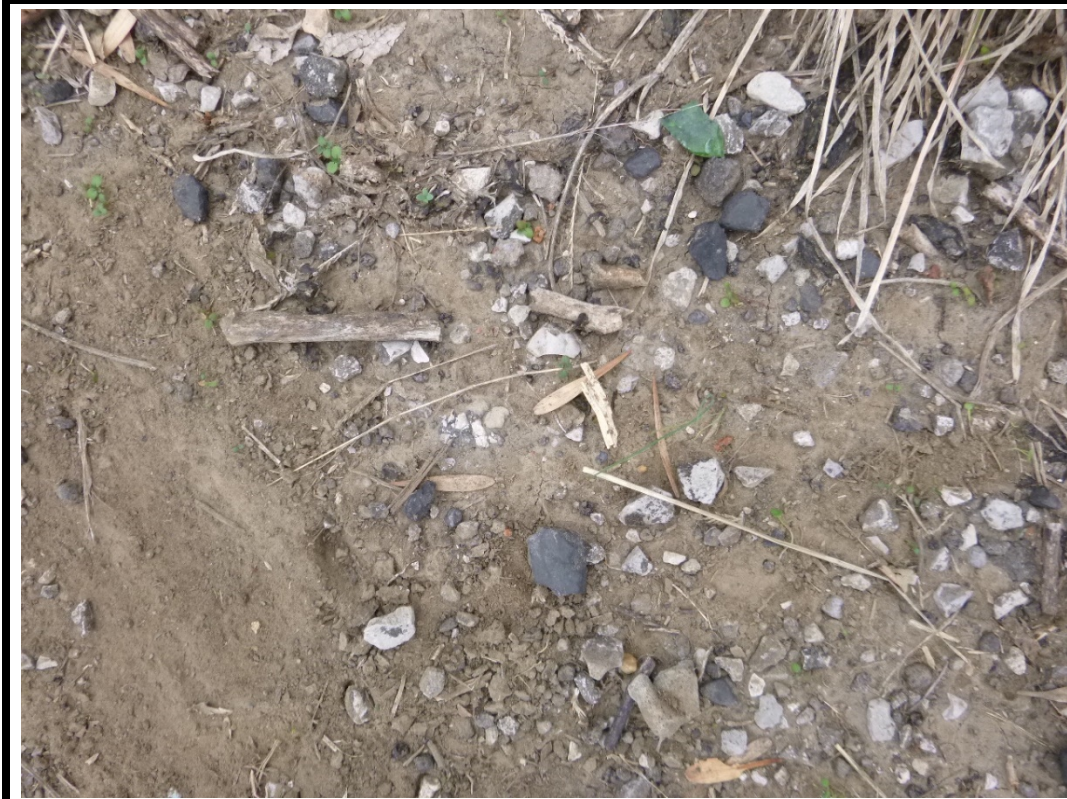
Photo ID: 10
Photo Date: 11/10/2020
Photo Time: 09:39
Direction: South
Taken By: Tom Miller

Battery chips on surface of
Schaeffer Road. Photo was
taken at 862 feet from the
entrance jersey barriers.

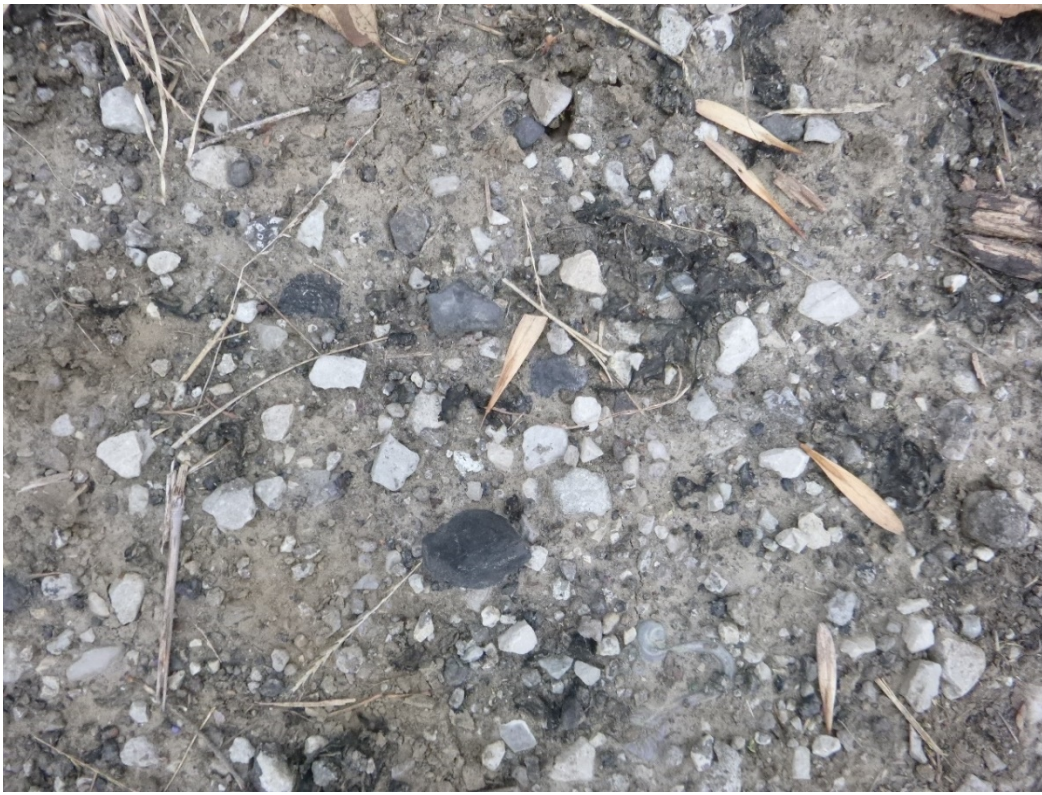
Photo ID: 11
Photo Date: 11/10/2020
Photo Time: 09:42
Direction: N/A
Taken By: Tom Miller

Battery chips on surface of
Schaeffer Road. Photo was
taken at 893 feet from the
entrance jersey barriers.

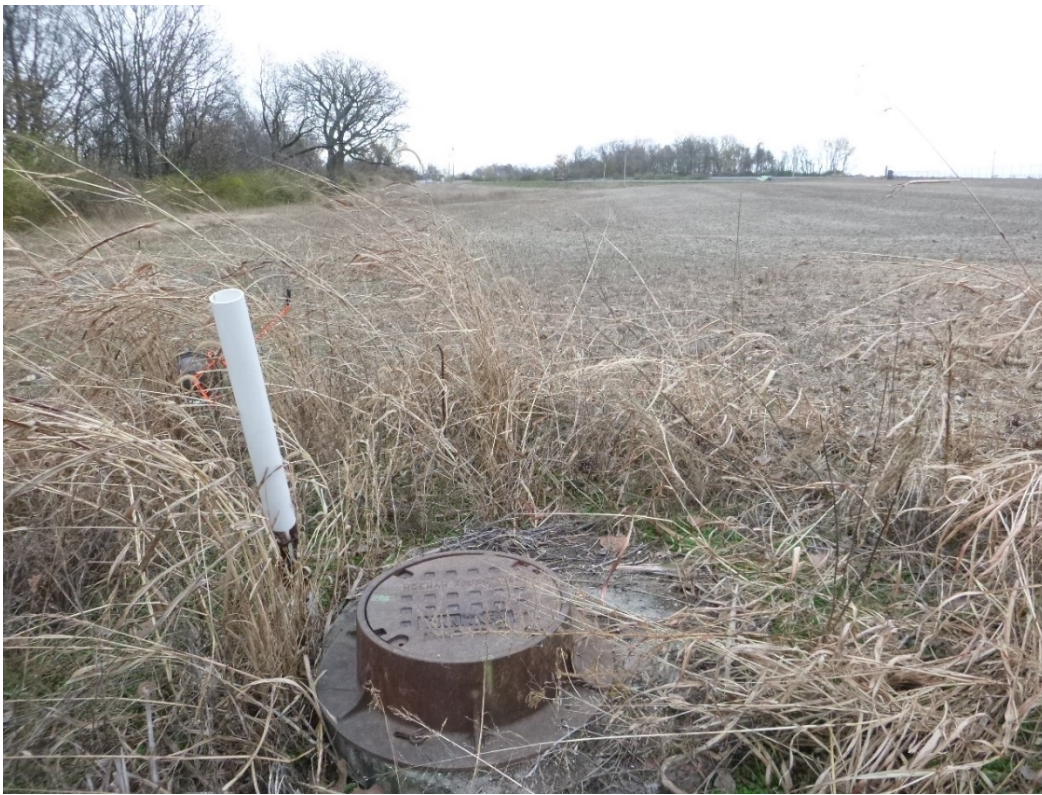
Photo ID: 12
Photo Date: 11/10/2020
Photo Time: 09:45
Direction: East
Taken By: Tom Miller

Sanitary Sewer manhole on
Schaeffer Road Property
located 1028 feet west of the
entrance jersey barriers.
Scattered battery chips were
observed in this area.

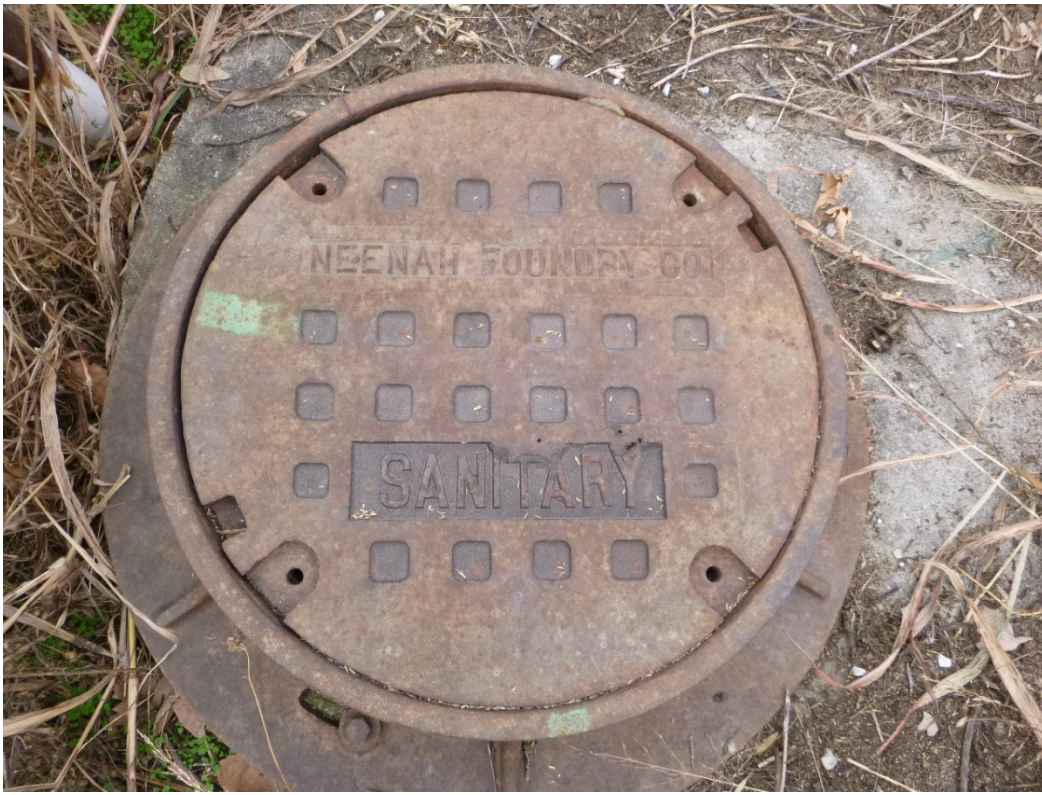
Photo ID: 13
Photo Date: 11/10/2020
Photo Time: 09:56
Direction: N/A
Taken By: Tom Miller

Sanitary Sewer manhole on
West end of Schaeffer Road.

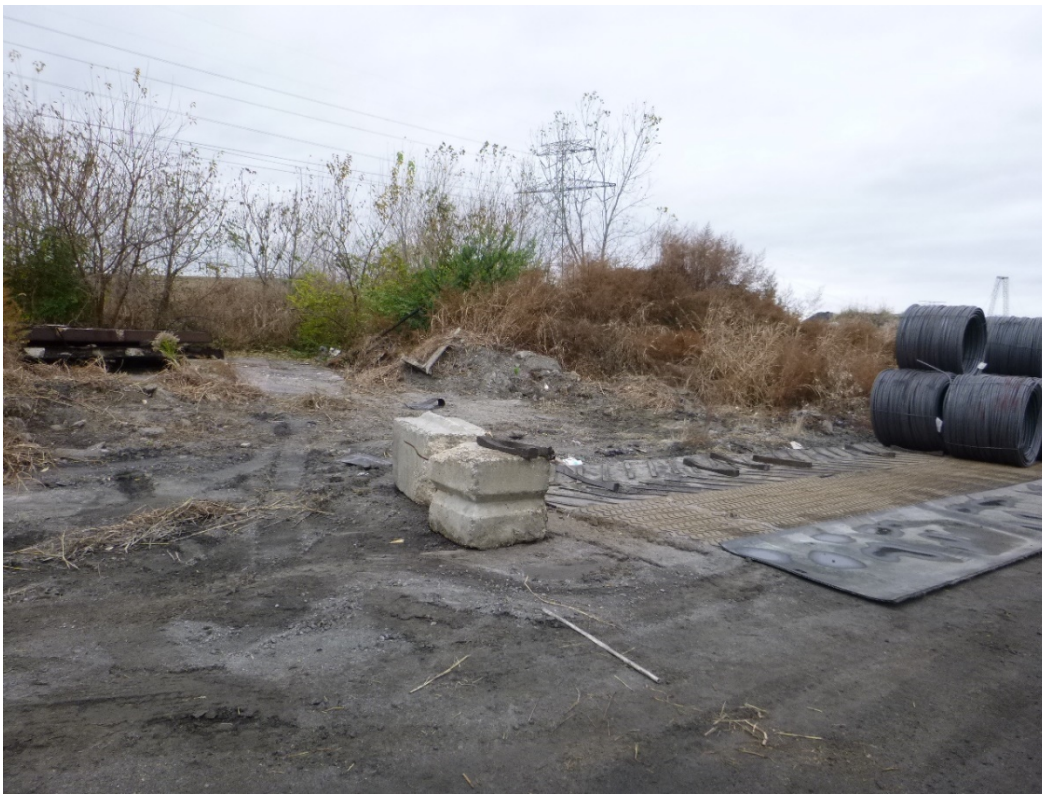
Photo ID: 14
Photo Date: 11/10/2020
Photo Time: 10:24
Direction: West
Taken By: Tom Miller

The next location we visited was a remote fill area known as Slough Road (Figure 4 and Photos 14 and 15). This area is located within the Beelman River Terminals, located off of Route 3 at 210 Bremen Street in Venice, Illinois. This area has been covered by an asphalt roadway, however there are a few scattered chips located off the road near an abandoned tavern foundation. The public does not have access to this area. We gained access by notifying the terminal manager of our visit and being allowed to drive to the area.

Former Robin's Nest Lounge
foundation area on Slough
Road within the Beelman River
Terminals, Inc. Property.

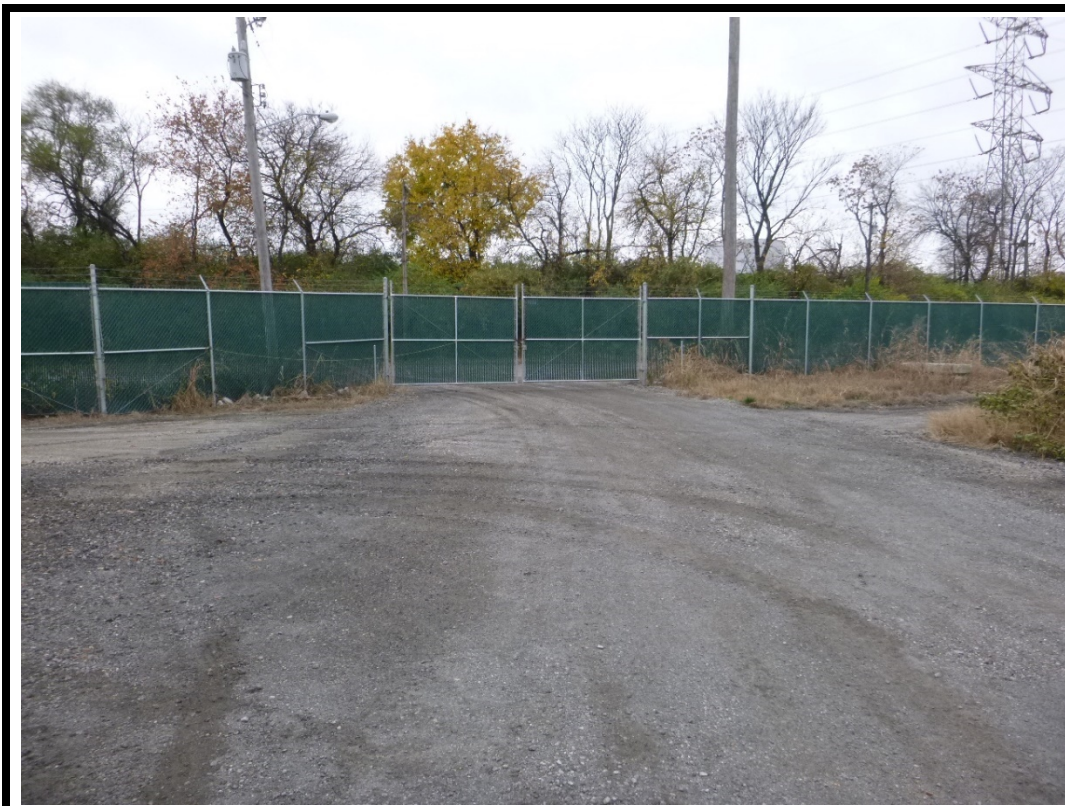
Photo ID: 15
Photo Date: 11/10/2020
Photo Time: 10:25
Direction: South/SW
Taken By: Tom Miller

Current Southern terminus of
Slough Road located with the
Beelman River Terminals Inc.
Property.

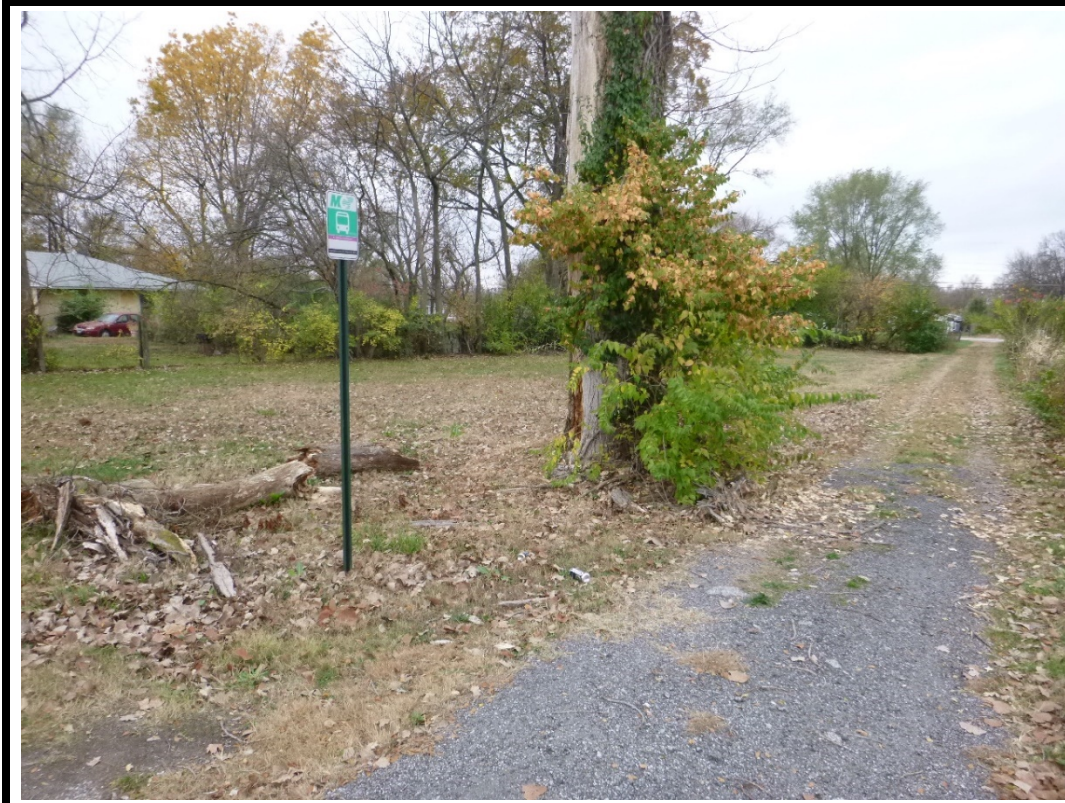
Photo ID: 16
Photo Date: 11/10/2020
Photo Time: 10:38
Direction: North
Taken By: Tom Miller

The next location we visited was Eagle Park Acres. While in this area we observed a property on Harrison Street that is a vacant lot where battery chips were observed by Jeff Leed, the NL/Taracorp Superfund Group oversight Contractor in May of 2019 (Figure 5 and Photo 16) we did not observe any visible battery chips at the time of our visit. We also observed two former residential remote fill related lead cleanup properties that were remediated during previous US EPA removal action activities and have been identified as areas that warrant further investigation due to data gaps. The first of these is located at **Non-responsive** the second property is located at **Non-responsive**. Both properties were well vegetated and there were no signs of visible battery chips at the time of our visit.

Harrison Street Property in
Eagle Park Acres.

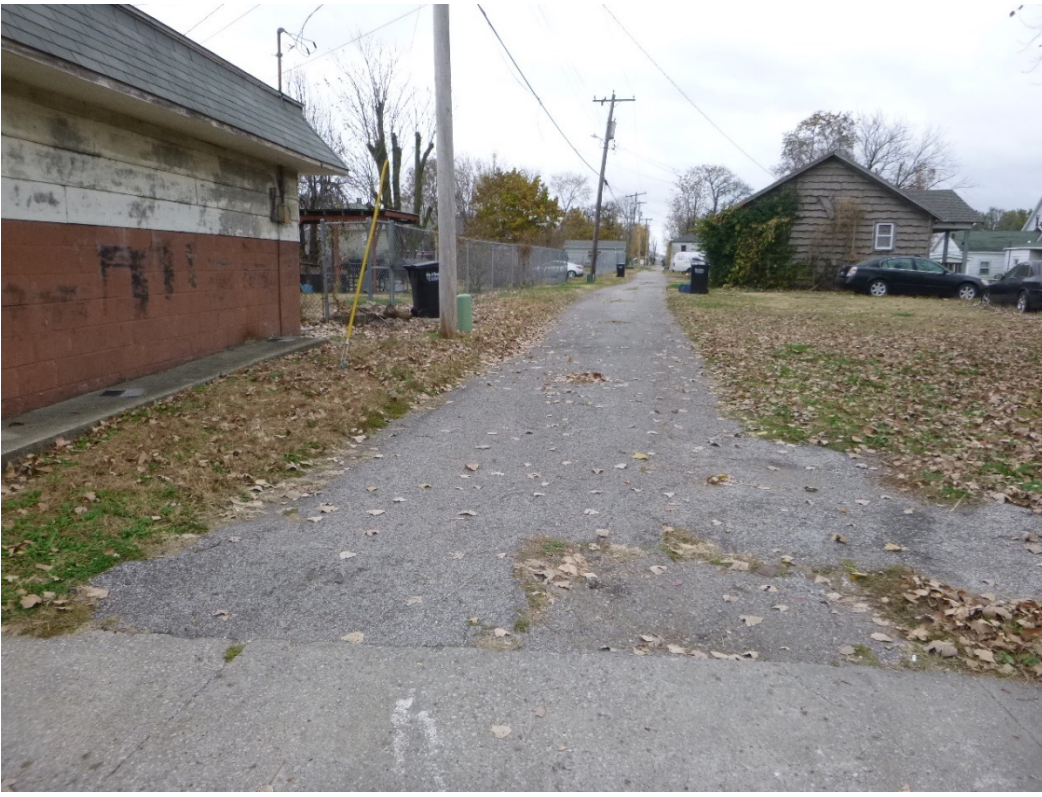
Photo ID: 19
Photo Date: 11/10/2020
Photo Time: 11:05
Direction: East
Taken By: Tom Miller

The next locations we visited were two paved alleyways in Venice that have remote fill materials remaining beneath engineered barriers. The first alleyway we observed is located off Baucum road between Market Street and Logan Street (Figure 6 - Photo 19). The second alleyway we observed was located on 6th Street Between Jefferson Street and Washington Street (Figure 6 - Photo 20).

Baucum Alleyway in Venice.

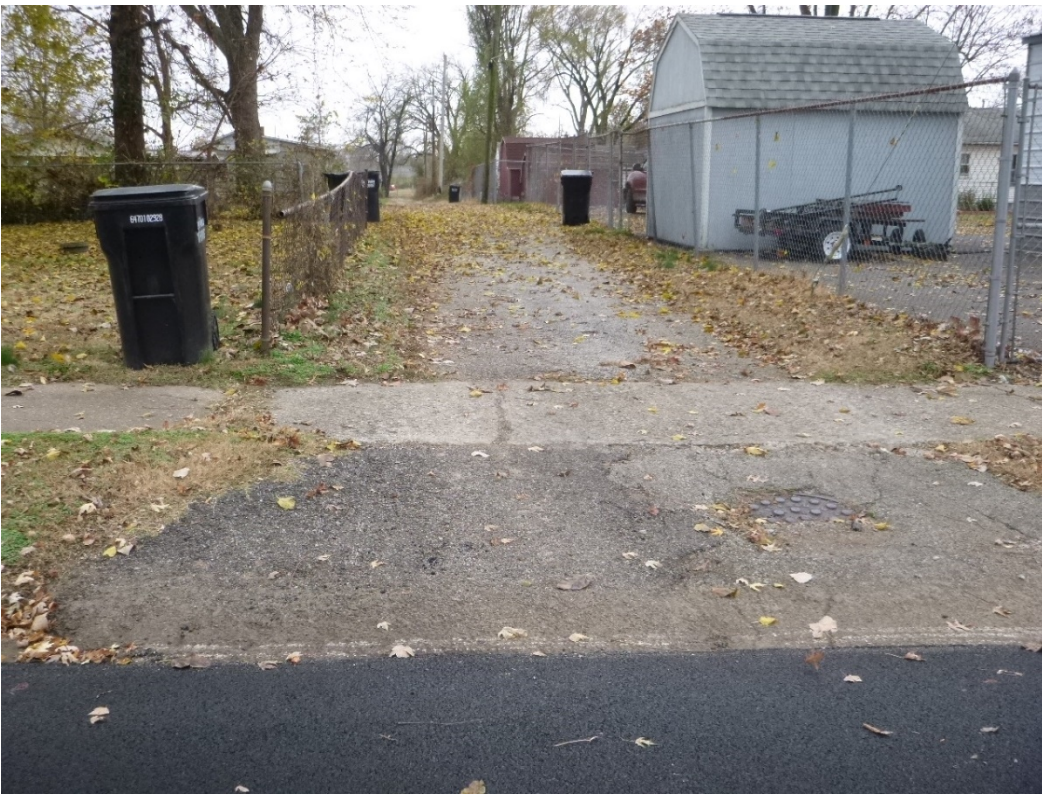
Photo ID: 20
Photo Date: 11/10/2020
Photo Time: 11:15
Direction: West
Taken By: Tom Miller

6th Street Alleyway in Venice.

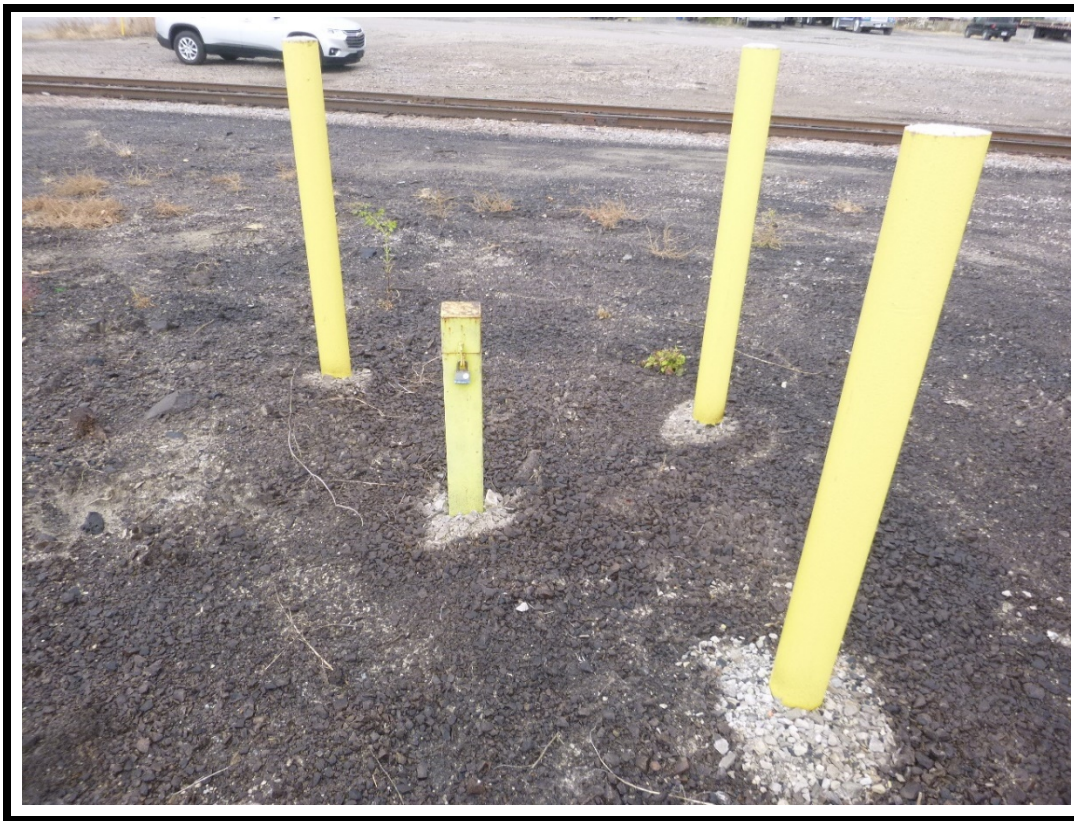
Photo ID: 21

We concluded our visit back at the former NL/Taracorp site. Prior to finishing our tour, Mr. Leed showed me an area in the northwest corner of the current Mayco MFG site where Monitoring Well MW5D is located (this well is part of NL/Taracorp groundwater monitoring network) (Figure 1 - Photo 21). While in the area, we observed a brown staining on the surface rock surrounding the monitoring well. Following the inspection, I reached out to Craig Rathgeb, Environmental Health and Safety Officer with Mayco Manufacturing. Mr. Rathgeb informed this writer that they had recently applied a dust suppressant to the area. The name of the material is Marathon - Petroleum Anionic Emulsified Asphalt. I suggested that during future applications they should refrain from applying the material within the bumper post area surrounding the monitoring well.

NL/Taracorp Battery Casing Pile
Monitoring Well Network well
MW5D. Dust suppressant
coating observed on gravel rock
surface.

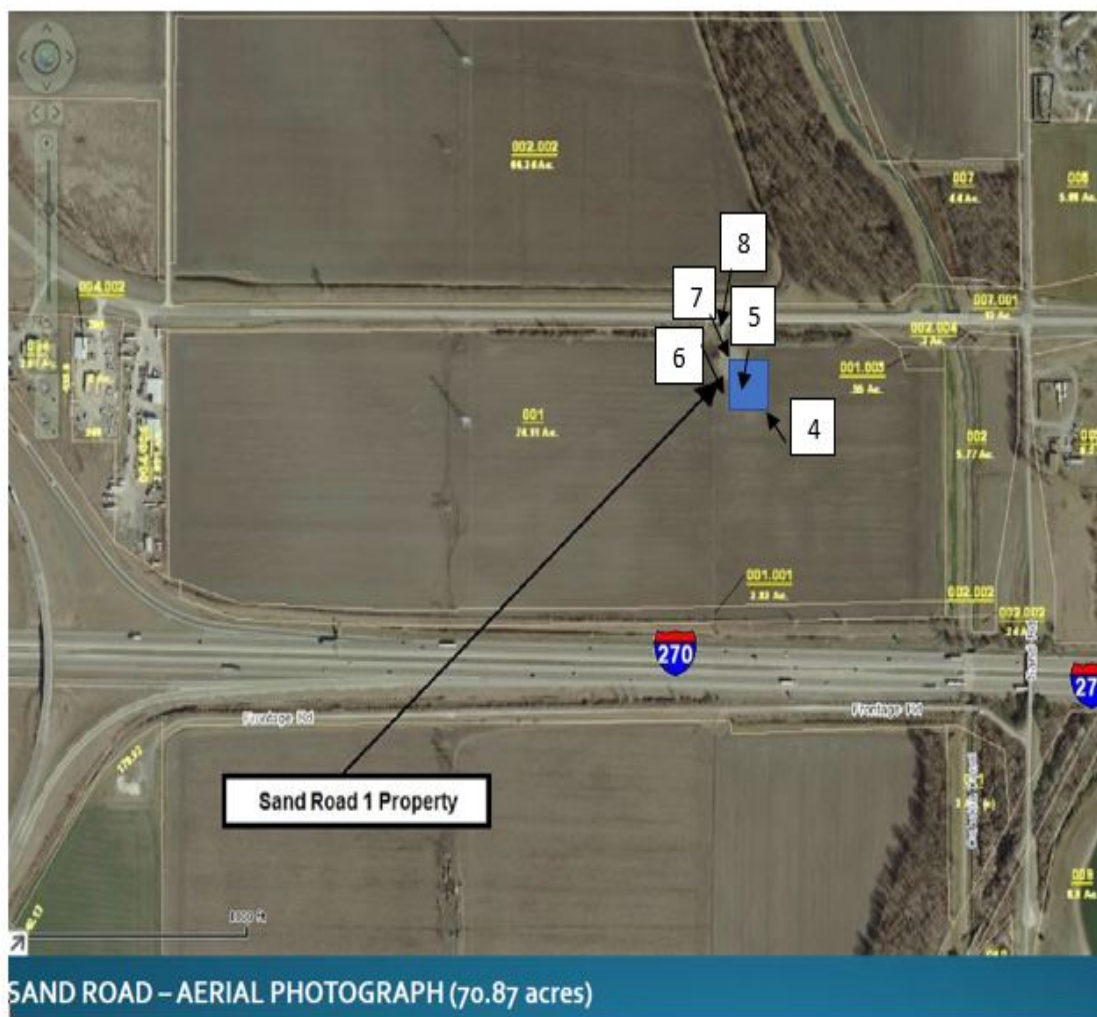
Figure 2 – Sand Road

Former house foundation

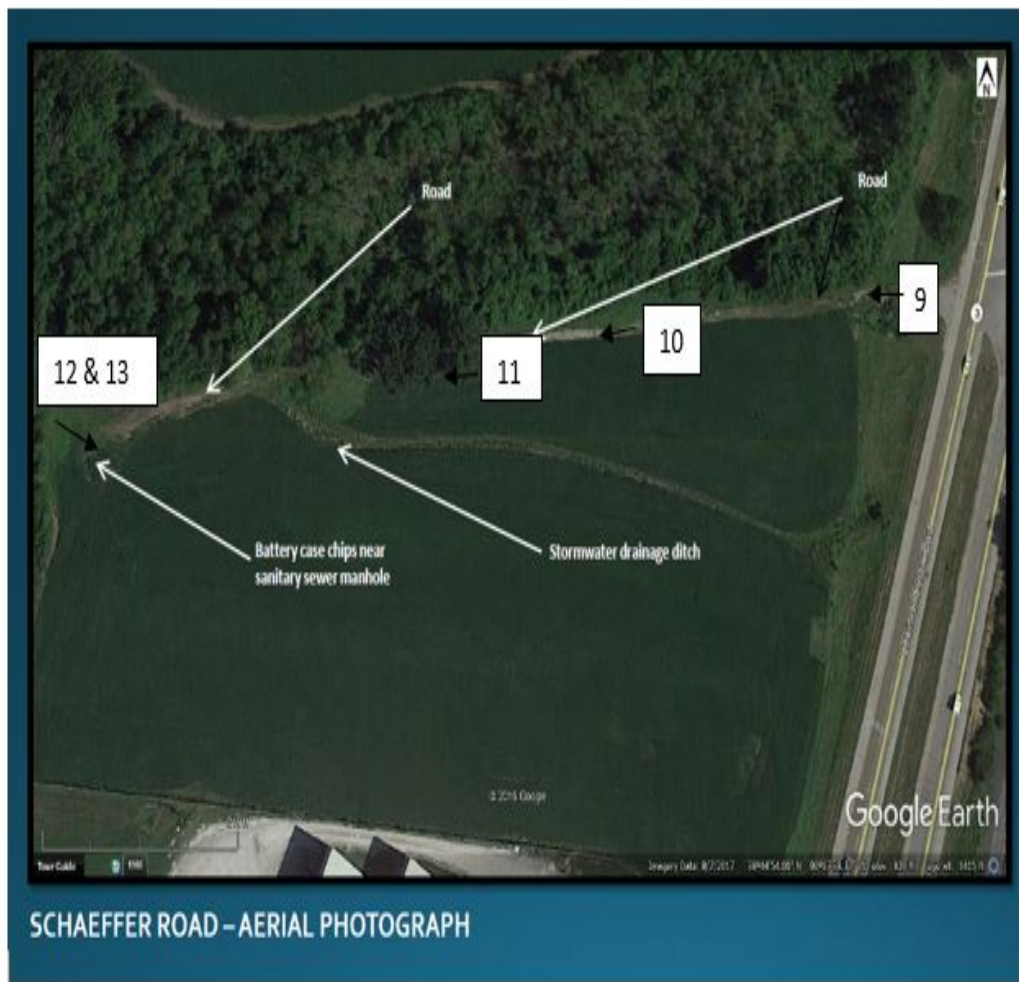
Figure 3 – Schaeffer Road

SCHAEFFER ROAD – AERIAL PHOTOGRAPH
